Polk County Conservation Water Quality Monitoring Program 2016-17 Annual Report December 1, 2017

Polk County Conservation 11407 NW Jester Park Drive Granger, Iowa 50109 www.leadingyououtdoors.org

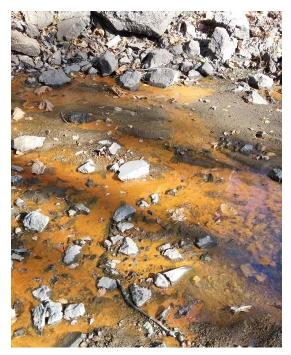
Figure 5. Milky-Green Water at Drainage Ditch 38 on June 6, 2017

Green water usually indicates the presence of algae. An oily sheen may be present as a byproduct of decomposition or may be due to chemical pollution. Rust or orange substances, often accompanied with an oil-like sheen, are due to natural occurring bacteria. Reddish or orange colored water indicates the presence of iron oxides. Blackish water occurs with leaf decomposition. These leaf pigments then may also cause the water to become murky. Milky water is caused by salts in the water. Gray water can be caused by both natural and human-made activities.

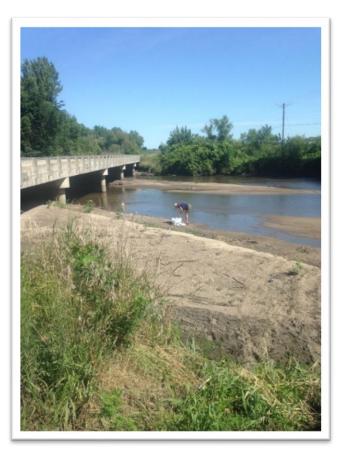
Figure 19. Beaver Creek Site 925036

The Beaver Creek watershed encompasses 244,347 acres and is dominated by agriculture with only a small fraction of urban acreage. Four sites in Beaver Creek watershed were identified for monitoring (Fig. 18) and one new site on Little Beaver Creek was added in the summer of 2017. The furthest upstream, site 925036 (Fig. 19), is just south of Granger in Dallas County. The site furthest downstream, site 977160 (Fig. 20), is located just north of I-80 near the Trestle to Trestle Trail. Site 977121, located on Little Beaver Creek, is near Crosshaven Park in Johnston.

middle-quality groups were present at sites 925036 and 977160. No macroinvertebrates were collected on site 977120 due to low water. Monitoring on site 977121 began after the Biological Assessment monitoring period. Site 925036 had an IBI of 2.33 indicating good benthic macroinvertebrate health. The IBI for site 977160 fell in the fair benthic macroinvertebrate population range.

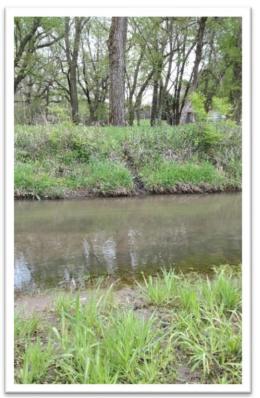
Figure 27. Big Creek Site 977192

Big Creek Site 977192 (Fig. 26) is located on Big Creek near All Sesaons Park in Polk City, Iowa. This creek, in part, is also referred to as Wolf Creek. The creek leaves Big Creek Lake, flows through and along the Tournamenet Club of Iowa golf course until reaching the water monitoring site. The creek flows along the park terminating at the Saylorville Wildlife Refuge. Monitoring on this site began on May 5, 2017. Nine assessments were completed during the 2016-17 season. The yearly average transparency was 29.89 cm (Fig. 32) which is lower than most sites (bottom 10% of all results) and consistenly lower than the median result during each assessment period. All other chemical/physical assessment results reported during this time are within normal range.

A biological assessment for this site was completed by indicating the present or absence of benthic macroinvertebrates. Because the number of macroinvertebrates found were not recorded, the IBI was not calculated.

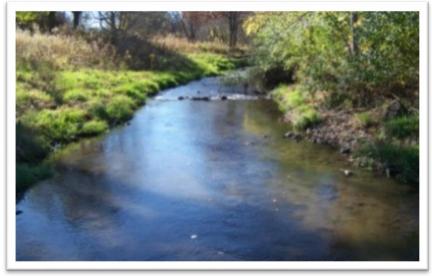
Figure 34. Camp Creek Site 977152

Three sites in Camp Creek were monitored. Sites 977152 and 977066 are located within Thomas Mitchell Park and site 977067 is located in the far southeast corner of the county near the Metro Waste Authority Environmental Learning Center (Fig. 33).

All categories of Benthic Macroinvertebrates (BMI) were found in small numbers at site 977152. The Biological Assessment at site 977066 and 977067 found only organisms in the BMI high- and middlequality groups. An IBI of 1.89 for site 977152 and 2.22 for site 977066 fell in the fair benthic macroinvertebrates range. An IBI of 2.29 for Site

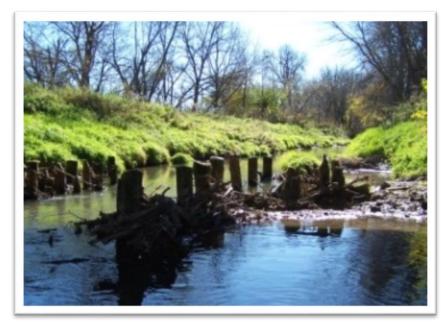
Figure 36. Camp Creek Site 977067

977067 fell in the good benthic macroinvertebrate population range.

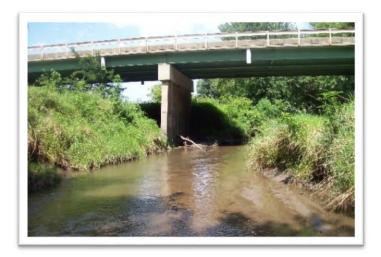
Figure 43. Mud Creek Site 977302

Benthic macroinvertebrates of high- and middle-quality groups were found at each site indicating an overall healthy stream of good water quality. The IBI results of 2.5 and 2.44 for sites 977302 and 977304 indicate good health and are some of the highest results for all monitored sites. The IBI of 2.07 for site 977303 fell in the fair benthic macroinvertebrate range.

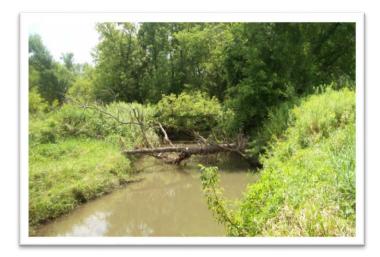
Figure 53. Spring Creek Site 977108

Phosphate concentration were high in January at site 977242 (Fig. 55). This site was dry during the drought in August 2017. The pH was slightly below normal, or slightly acidic, once in January at site 977108.

Benthic macroinvertebrates from all quality groups were found at both sites. The IBI results of 1.84 and 2.00 for sites 977108 and 977242 fell in the fair benthic macroinvertebrate range. As no significant issues were found at either of the two water monitoring sites, the creek is considered safe for recreational use.

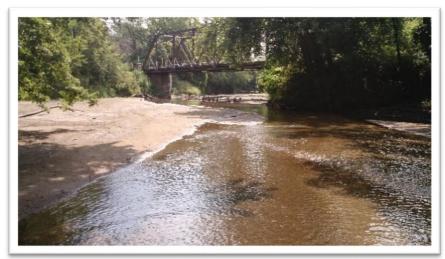
Figure 60. Indian Creek Site 977327

Monitoring began on Indian Creek site 977327 in mid-June 2017 (Fig. 60). This site experienced high phosphate levels, ranging between 1 mg/L and 5 mg/L, well over the 0.6mg/L threshold (Fig. 66). The site experienced low dissolved oxygen concentrations in July 2017 (Fig. 68).

Indian Creek's IBI was zero due to very low numbers of

benthic macroinvertebrates found at the site. This may indicate a degraded habitat, higher levels of pollution or may be a result of the low water levels and drought.

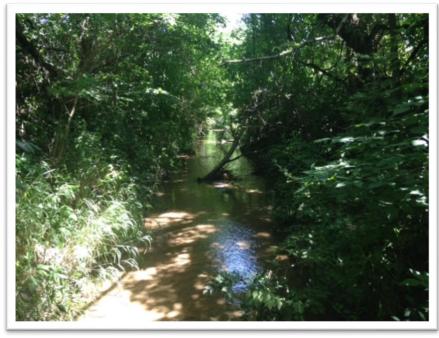
Figure 61. Carney Creek Site 977307

(Fig. 61) reported "clear" water color throughout the year, even after rain. This heavily vegetated site flows through well-managed pastureland before entering Chichaqua Bottoms Greenbelt. This decreases sediment load in runoff resulting in clearer water when other more eroded and less vegetated creeks will carry sediment after rainfall.

and July (Fig. 66). Chloride concentrations remained low, well below the normal range (Fig. 69). Low dissolved oxygen and slightly above normal nitrate and phosphate concentrations were reported in July, likely due to lower than normal stream flow, shallow depths and rising water temperatures common during summer (Fig. 68, 65, 66). The creek went dry in August and remained dry through the rest of our reporting period.

Carney Creek site 977307 reported an IBI of 1.33, which indicates a poor benthic macroinvertebrate population present. This is likely the result of the low water levels and drought conditions.

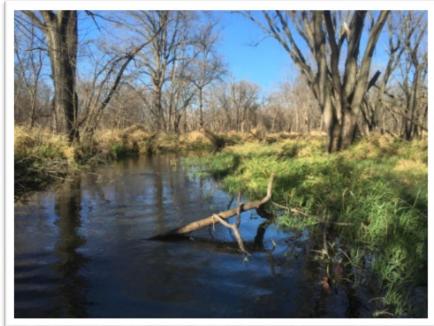
Figure 62. Drainage Ditch 4 Site 977310

for the last two monitoring events in August and September 2017.

Despite low dissolved oxygen results and drought conditions that resulted in a dry creek bed in late August and September the IBI of near 2.0 indicated the presence of a fair benthic macroinvertebrate population present.

Drainage Ditch 4 Site 977310 (Fig. 62) consistently reported low dissolved oxygen throughout the year (Fig. 68). Phosphate concentrations were low through most of the year with slightly elevated levels in fall 2016 and in summer 2017 and once in January 2017 (Fig. 66). Seasonal averages for nitrates ranged from 0 to 5 mg/L, well below the drinking standard of 10 mg/L (Fig. 65). Chloride readings were consistently low throughout the year (Fig. 69). This site was dry

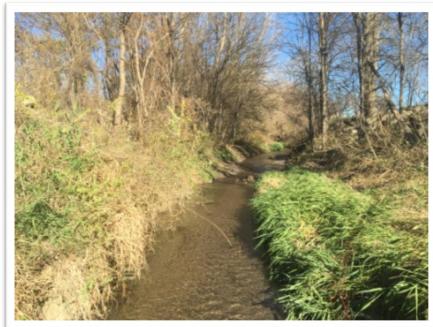
Figure 63. Bluff Creek Site 977306

from adjacent agricultural land. The site was dry during September 2017.

Bluff Creek Site 977306 (Fig. 63) reported abnormally low dissolved oxygen in fall 2016 and late spring through the rest of the year, characteristic of shallow and warm streams (Fig. 68). Monitoring was not possible in mid-December through January when the creek froze. Nitrate, phosphate and chloride concentrations were normal throughout the year (Figs. 65, 66 & 69).

This site is heavily vegetated which decreases the sediment load in runoff

The biological assessment resulted in an IBI of 1.44 indicating a poor benthic macroinvertebrate population for Bluff Creek site 977306.

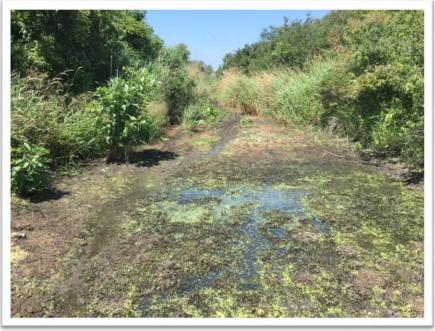
Figure 64. Low Water at Drainage Ditch 38 Site 977311

The biological assessment resulted in an IBI of 2.11 indicating a fair benthic macroinvertebrate population at site 977311.

Drainage Ditch 38 Site 977311 (Fig. 64) reported very low dissolved oxygen throughout the year (Fig. 68). Green, reddish, milky and oily water throughout the winter and again in the summer were noted. Algal mats present in summer assessments and low dissolved oxygen results with an oily sheen were reported to the Iowa DNR. This site went dry in August and remained dry through the rest of the monitoring period. Monitoring on Santiago Creek Site 977322 began in June, 2017 (Fig. 65). Only three assessments were obtained before the creek went dry in August 2017 and remained dry through the 2016-17 reporting period. High nitrates were reported in June (Fig. 66). Low dissolved oxygen and high phosphates occurred in July due to drought conditions (Figs. 67 & 69).

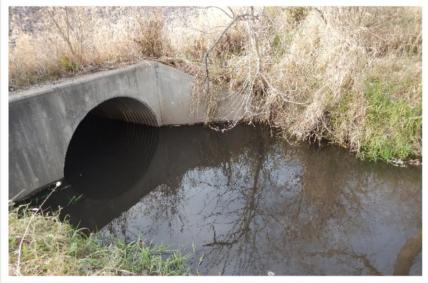
Figure 72. Case Lake Inflow Site 977326

Case Lake Inflow Site 977326 (Fig. 72) is located south of James W. Cownie Soccer Park on Hartford Avenue in Des Moines. Three field assessment forms were completed during this reporting period. These results were normal with the exception of a low dissolved oxygen result of 3 mg/L in July (Fig. 80) and a high phosphate concentration of 0.6 mg/L in August (Fig. 78).

The biological assessment

resulted in an IBI of 1.6 indicating a poor benthic macroinvertebrate population for Case Lake Inflow site 977326.

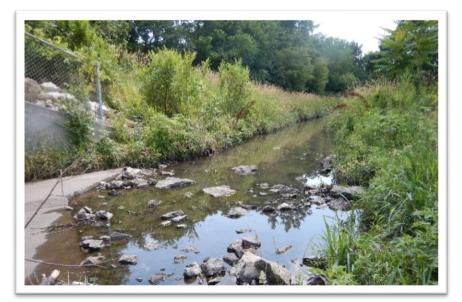
Figure 73. Crawford Creek Site 977325

Crawford Creek Site 977325 (Fig. 73) is located on the west side of Southeast Ninth Street between East Edison Avenue and East Hillside Avenue. This creek flows northeast into the flood control structure prior to going into the Des Moines River. Four field assessment forms were completed, however once during the September assessment the creek was dry. The results were normal with the exception of a pH result of 5 in early July.

The biological assessment resulted in an IBI of 2.0 indicating a fair benthic macroinvertebrate population at Crawford Creek site 977325.

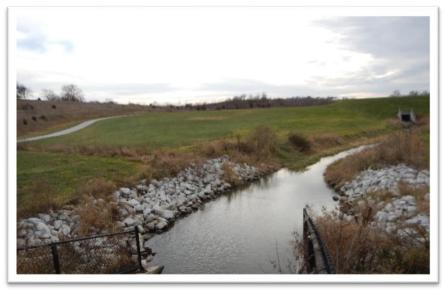
Figure 74. Magnolia Creek Site 977323

Magnolia Creek Site 977323 (Fig. 74), located in Three Lakes Estates along Southeast 60<sup>th</sup> Avenue, began monitoring in early July. The four completed assessments did not report any abnormal results.

The biological assessment resulted in an IBI of 2 indicating a fair benthic macroinvertebrate population for Magnolia Creek site 977323.

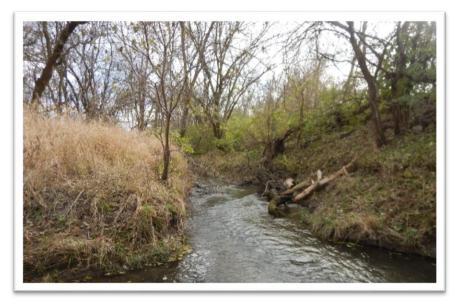
Figure 76. Frink Creek Site 977082

Monitoring on the Frink Creek Site 977082 (Fig. 76) began in early July 2017. All results on the four completed assessments were within normal range.

The biological assessment resulted in an IBI of 1.6 indicating a poor benthic macroinvertebrate population for Frink Creek Site 977082.

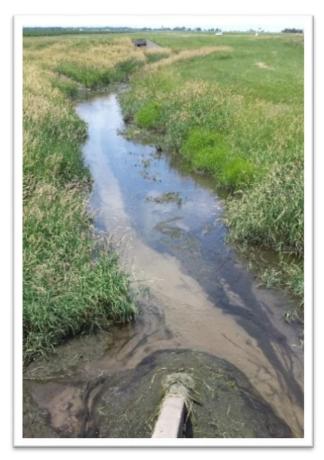
Figure 83. Fourmile Creek Site 977072

Fourmile Creek Site 977072 (Fig. 83) is by far the most rural sampling site in the Fourmile Creek watershed and is the only site which experienced high phosphate concentrations throughout much of the year (Fig. 93). High nitrate readings of 10 mg/L occurred spring through summer with one 20 mg/L concentration in May 2017 (Fig. 92). A manure smell and very high chloride concentration occurred in July during low creek flow.

Benthic macroinvertebrates were present from the BMI middle- and low-quality groups indicating some degree of pollution and habitat degradation. The IBI of 1.31 would indicate a poor benthic macroinvertebrate population present.

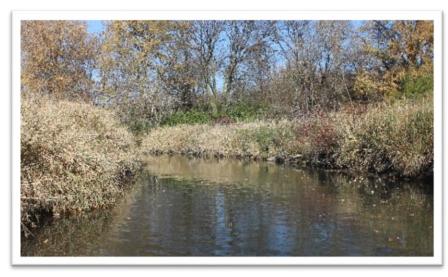
Figure 84. Fourmile Creek Site 977301

Monitoring at site Fourmile Creek Site 977301 (Fig. 83) in northern Ankeny was suspended due to bridge construction. One field assessment was completed in March 2017.

No Biological Assessment was completed at this site due site closure.

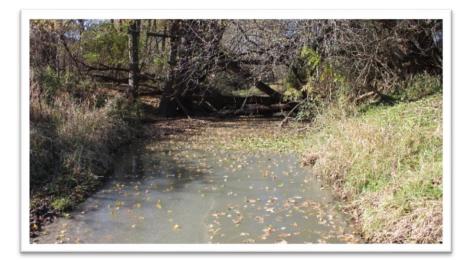
Figure 85. Fourmile Creek Site 977309

Deer Creek Site 977309 (Fig. 85) is located upstream of its confluence with Fourmile Creek in Ankeny. This site reported higher than normal phosphate concentrations in January 2017 (Fig. 93). Nitrate levels were above drinking water standard in fall 2016 and spring through summer 2017 with a very high reading in May 2017 (Fig. 92). Upstream from the site are housing developments and agricultural land.

A biological assessment was completed in July 2017. Species were found from BMI middle-quality group BMI low-quality group. The IBI for this site indicated a poor benthic macroinvertebrate population present.

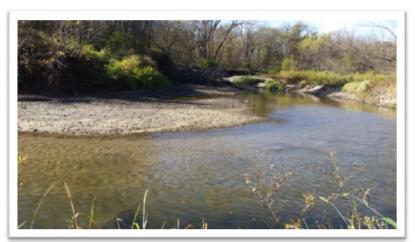
Figure 86. Fourmile Creek Site 977079

Fourmile Creek Site 977079 (Fig. 86) located in Mally's Weh Weh Neh Kee Park and Muchinknock Creek Site 977312 (no photo) also had higher than normal phosphate concentrations in fall 2016 and summer 2017 (Fig. 93). Nitrate, pH and chloride concentrations remained normal at these sites.

977312. The benthic macroinvertebrates found in the 2015-16 assessment indicated good water quality but the IBI for 2016-17 indicates a poor benthic macroinvertebrate population. This is likely to due to low rainfall throughout the area during the summer of 2017. A biological assessment was not completed for site 977079.

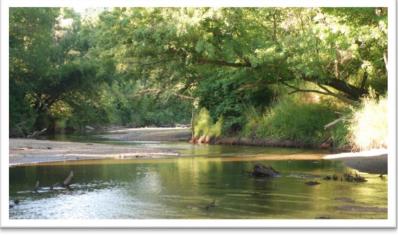
Figure 87. Fourmile Creek Site 977073

Fourmile Creek Site 977073 (Fig. 87), located near Sleepy Hollow, and Fourmile Creek Site 977308 (Fig. 88), at Vandalia Road near Highway 65, had normal nitrate, pH and dissolved oxygen readings all year. Phosphate concentrations at these sites, like most PCCWQMP sites, were high in January 2017 (Fig. 93). Site 977073 reported one spike in chloride concentration (115 mg/L) in September 2017 Figu when water flow was at its lowest (Fig. 95).

A biological assessment was completed for site 977073. Benthic macroinvertebrates were present from all BMI quality groups. The IBI of 2.0 would indicate a fair benthic macroinvertebrate population present at this time.

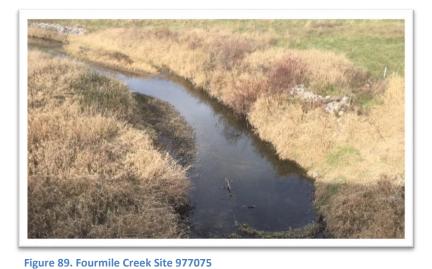
Fourmile Creek site 977075 (Fig. 89) is located in northern Ankeny along the edge of a residential area. Upstream from the site is agricultural land. Monitoring began on this site in mid-July. This site reported low dissolved oxygen in July and August (Fig. 94). Only two assessments were completed before it went dry in September 2017.

A biological assessment was

completed for this site. Species found were from the BMI low-quality group. The resulting IBI of 1.05 for this site indicated a poor benthic macroinvertebrate population.

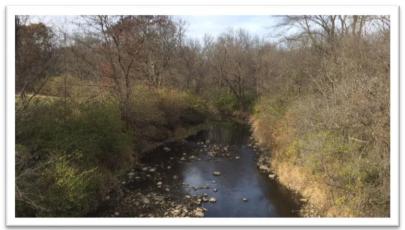
Figure 90. Fourmile Creek Site 977078

Fourmile Creek site 977078 (Fig. 90) located near Southeast Oralabor Road northeast of the airport in Ankeny began monitoring in mid-July 2017. Three assessments were completed. The dissolved oxygen concentration reported in July was below normal but all other readings were normal (Fig. 94).

The IBI of 1.7 indicated this site has a poor benthic macroinvertebrate population present at this time.

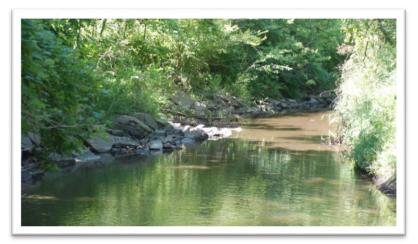
Figure 91. Little Fourmile Creek Site 977321

Little Fourmile Creek Site 977321 (Fig. 91) is located near East University in Pleasant Hill. Monitoring began in mid-July with three assessments completed. One very high chloride result of 209 mg/L was reported in September 2017 (Fig. 95). All other results fell within the normal range. A low number of species found during the July biological assessment resulted in the IBI of 2.00, which indicates a fair benthic macroinvertebrate population present.

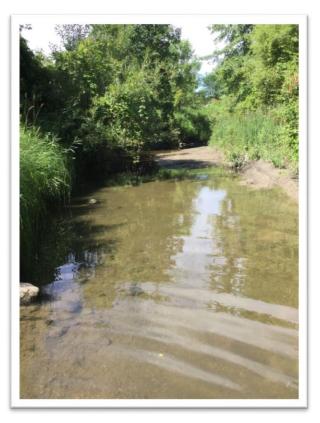
Figure 98. Jordan Creek Site 977085

Biological assessments indicating the present or absence of benthic macroinvertebrates were **completed; therefore, an IBI** was not calculated. Jordan Creek Site 977085 (Fig. 98) is located along the Jordan Creek Trail east of Interstate 35. Monitoring began in mid-July 2017 with five completed assessments. No abnormal results were found.

The biological assessment was completed for this site in July 2017. Species in the high- and middlequality groups were noted. Because the number of benthic macroinvertebrates was not recorded, an IBI could not be calculated for this site.

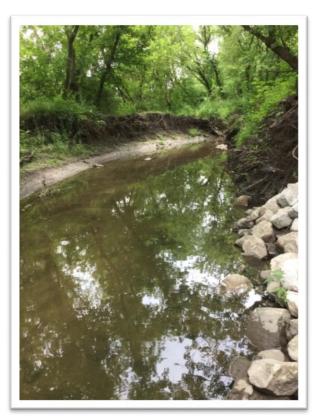
**Figure 99. Jordan Creek Site 977270 59** | P a g e

Jordan Creek Site 977270 (Fig. 99) is located at Walking Trail Bridge north of E. P. True Parkway in West Des Moines east of Interstate 35. Monitoring began in mid-July 2017 with four completed assessments. One high chloride concentration of 104 mg/L was reported in July 2017 with remaining results normal (Fig. 106).

The biological assessment completed for this site in July 2017, resulted in only one high-quality benthic macroinvertebrate found so the IBI could not be calculated. Jordan Creek Site 977029 (Fig. 100) is located near Mills Civic Parkway near the West Des Moines Police Department in West Des Moines. Monitoring began in mid-July 2017 with five completed assessments. No abnormal results were found.

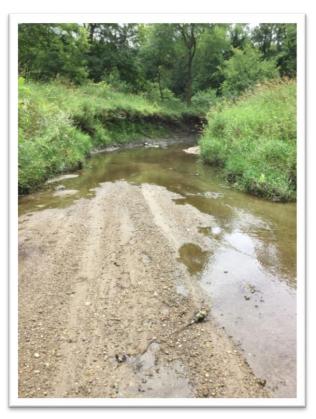
Figure 100. Jordan Creek Site 977029

The biological assessment was completed for this site in July 2017. No benthic macroinvertebrates were collected.

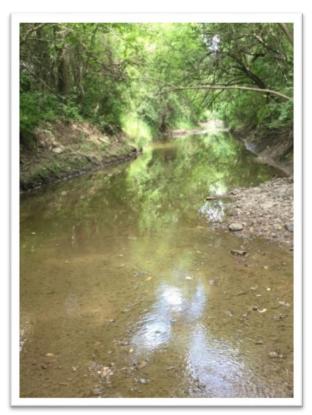
Figure 101. Jordan Creek Site 977150

Jordan Creek Site 977150 (Fig. 101) is located in Raccoon River Park along the Jordan Creek Trail in West Des Moines. Monitoring began in mid-July 2017 with five completed assessments. No abnormal results were found.

The biological assessment completed for this site in July 2017 found no benthic macroinvertebrates.

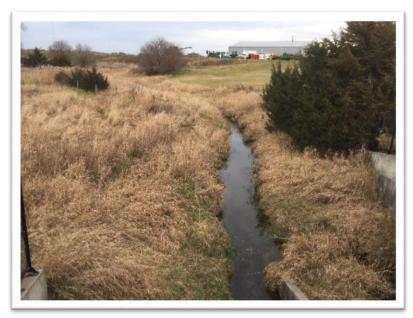
Figure 115. Rock Creek Site 977104

Monitoring began on three sites along Rock Creek in July 2017. Site 977196 (no photograph available), located on the High Trestle Trail and site 977104 (Fig. 115), approximately 0.5 miles downstream along NW 18<sup>th</sup> Street, are surrounded by agricultural land. Site 977105 (Fig. 116), located two miles south on Northwest Polk City Drive, is south of Ankeny Golf and Country Club.

The biological assessments were completed for all three sites however, few benthic macroinvertebrates were found. Site 977196 did not find any species, sites 977105 and 977105 reported species from the BMI middle-quality and low-quality groups indicating a poor benthic macroinvertebrate population.

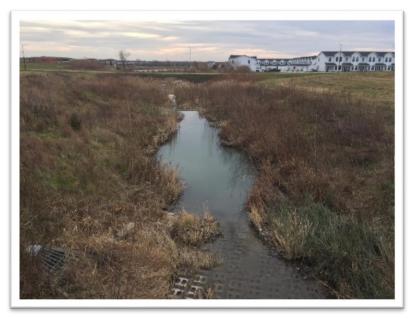
Figure 123. Saylor Creek Site 977189

Saylor Creek Site 977189 (Fig. 123) experienced both low dissolved oxygen and high chloride readings in July and August prior to drying up in September (Figs. 128 & 129). Downstream, site 977106 (Fig. 124) did not report any abnormal readings.

The biological assessments were completed for the two Saylor Creek sites in July 2017. Benthic macroinvertebrates were found in BMI middle-quality and low-quality groups. The calculated IBI for site 977189 was 1.25 and for Site 977106 was 1.2, indicating a poor benthic macroinvertebrate community for both sites.

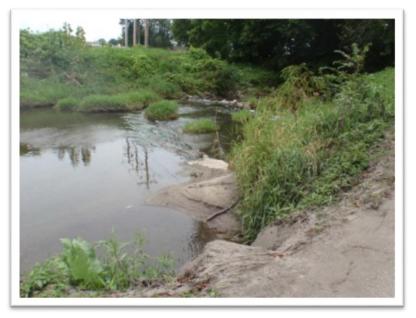
Figure 131. North Walnut Creek Monitoring Site 977099

North Walnut Creek Site 977099, (Fig. 131) is located along the trail at Walker Johnson Park in Urbandale. This site had high phosphate, high chloride and low pH readings in January (Figs. 136 & 138). The high chloride concentrations continued through March with the maximum reading of 300 mg/L reported in mid-March. Chloride levels were consistently higher than for all other Walnut Creek sites monitored during this period (Fig. 138). This location has direct runoff from a road, a paved trail and Walker Johnson Park parking lot so the saltladen runoff could explain the high

A biological assessment was completed in July 2017. The presence of one benthic macroinvertebrate from the BMI high-quality, ten from the BMI middle-quality and three in the low-quality groups were found resulted in an IBI of 1.86. This indicates a fair benthic macroinvertebrate community present.

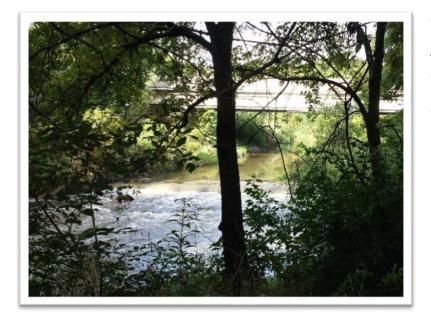
#### Figure 132. Walnut Creek Site 977112

## Walnut Creek Site 977112 (Fig. 132) is located along the Clive Greenbelt Trail west of 100<sup>th</sup> Street. There were elevated phosphate levels in mid-January, which coincided with the elevated levels all other areas experienced during this timeframe (Fig. 136). Chloride readings were below the threshold throughout the year (Fig. 138). Nitrate levels reached the drinking water standard (10 mg/L) and 20 mg/L in spring and early summer 2017. Seasonal nitrate averages remained below 9 mg/L (Fig. 135).

A low number of benthic macroinvertebrate species were found for a second year in a row at

this site. The IBI result of 1.25 indicated a poor benthic macroinvertebrate community. Only eight benthic macroinvertebrates were found, two from BMI middle-quality group and six from BMI low-quality group, which may indicate some degree of pollution or habitat degradation.

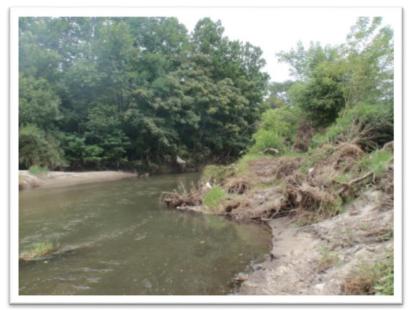
Figure 134. Walnut Creek Site 977197

Walnut Creek Site 977197 (Fig. 134) is located east of 63<sup>rd</sup> Street and south of Grand Avenue in Des Moines. This site had normal dissolved oxygen readings (Fig. 137). The pH levels dropped to 5 in January and March 2017. One elevated phosphate reading of 3.0 mg/L was reported in January when all PCCWQMP sites were higher than the 0.6 mg/L threshold (Fig. 136). Nitrate readings were at the drinking standard of 10 mg/L in October 2016, April and May 2017 and reached 20 mg/L in early October 2016. Seasonal nitrate averages remained below 9mg/L (Fig. 135).

Low numbers of benthic macroinvertebrates were found in the BMI middle-quality group and lowquality group. The calculated IBI of 1.58 indicates a poor benthic macroinvertebrate community.

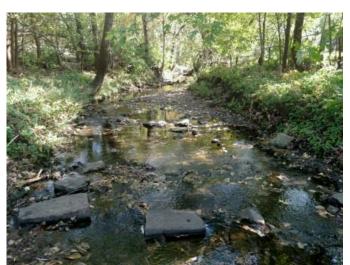
Figure 141. Yeader Creek Site 977273

Dissolved oxygen concentrations dropped to extremely low levels in July 2017. The

Biological assessments were conducted in late July 2017 at all four Yeader Creek sites. No benthic macroinvertebrates were found at site 977305, one benthic macroinvertebrate at sites 977003 and 977273. The biological assessment for site 977117 found eight from the middle-quality group and over 50 from the BMI low-quality group. An IBI of 1.13, calculated for site 977117, indicated a poor benthic macroinvertebrate community present. Yeader Creek is considered an impaired waterway and recreation in the creek is not advised.
